Development of Long Life Overlays for Existing Pavement Infrastructure Projects in New Jersey

Northeast Asphalt User/Producer
Group Meeting
October 18, 2001

**Robert Sauber
Design Services
New Jersey Department of Transportation**

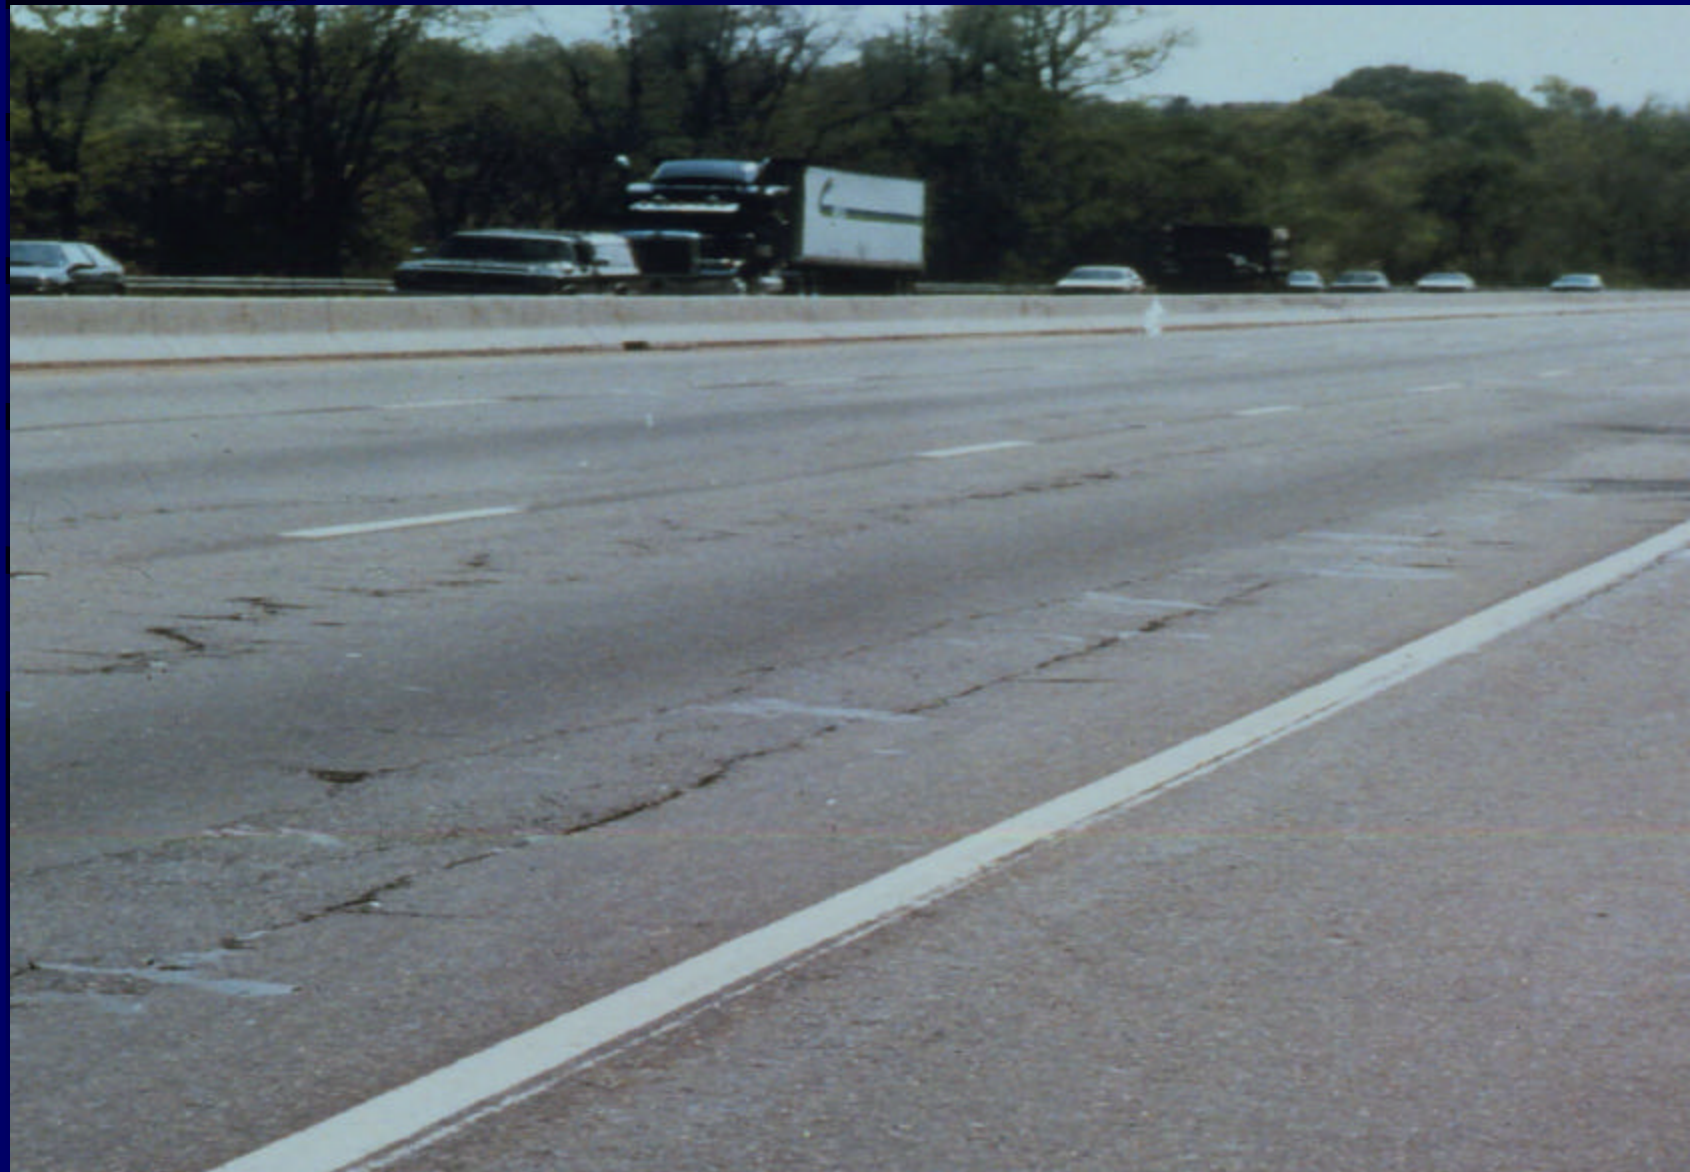
Typical Surface Appearance

- 1994 Visual Condition Survey
 - Lanes 2 and 3
 - Moderate to high severity fatigue cracking
 - Wheel path longitudinal cracking
 - Some high severity patching
 - Rutting >1”
 - Lane 1
 - Low severity cracking
 - Rutting <1”

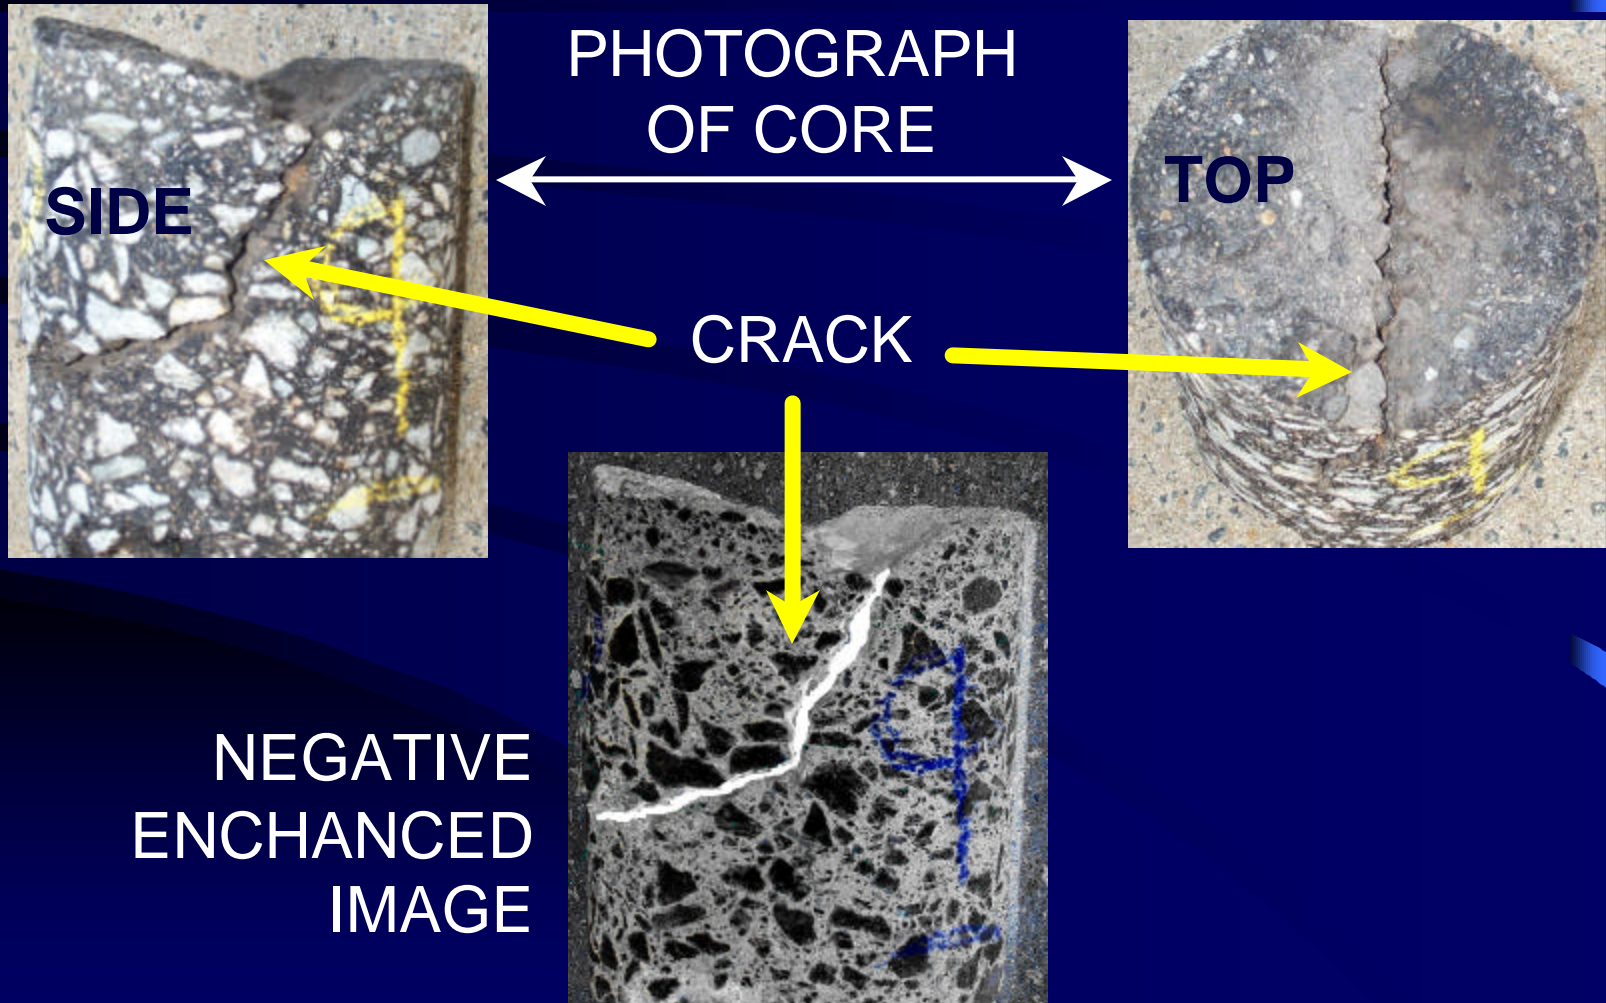
Example of Surface Cracking

- Initial indications were that cracks penetrated through all bound layers
- Coring results
 - Cracks originated at surface with majority stopping at the base layer (3" depth)
 - Materials testing
 - 25 Pavement cores

- Pavement is surface cracked
- Classical models do not help us to predict this distress
- Possibly a result of very hard binder in the surface mix

- Mill 3" depth (removes most cracks)
- Overlay
 - 2" HMA surface course, polymer modified
 - 2" minimum HMA base course [stone mix]
 - Test area with 1200 tons of NJ's first Superpave mix
 - Minimal modification needed to convert existing mixture to meet 12.5 mm Superpave requirements

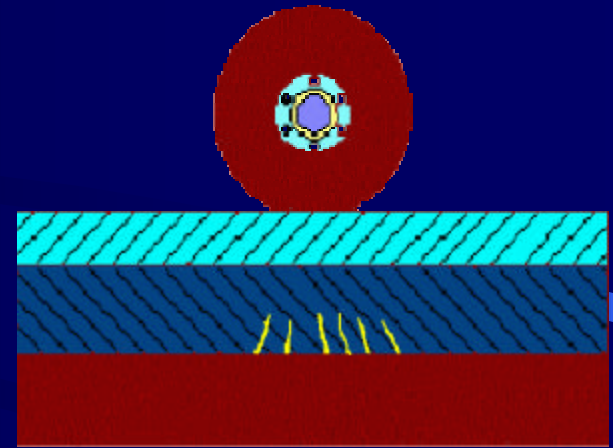
- Extensively cracked pavement
- Cracks originate at the top and restricted to top 3 inches
- Few cracks through entire layer

Typically
cracks
assumed to
start here!

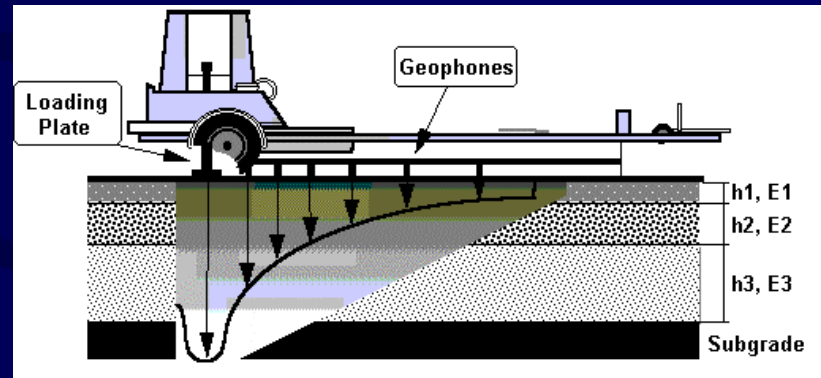
Route I- 287 FWD Testing

– NB1	7,100 MPa
– NB2	5,600 MPa
– NB3	4,600 MPa
– SB1	7,600 MPa
– SB2	5,300 MPa
– SB3	4,900 MPa

- NB= North Bound, SB= South Bound, 1= fast lane, 3= slow lane.
- Lane 3 has considerably lower stiffness compared to lane 1.

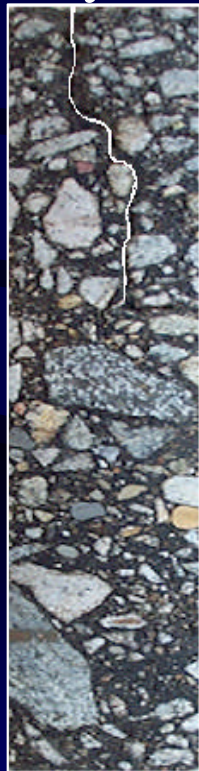
Lane 3
slow lane
heavy traffic

Cracked
top layer

Sound
base of
high
stiffness

**Combined Stiffness
= 4,750 MPa**

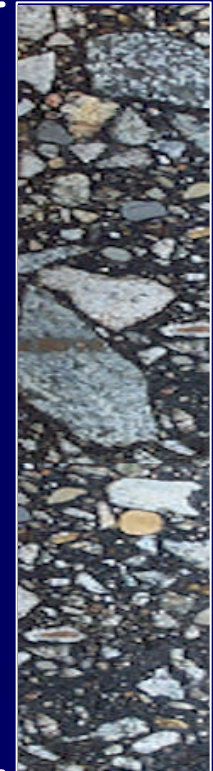
Lane 1
fast lane
light traffic

Sound
pavement
structure
with
minimal
cracking

**Combined Stiffness
= 7,350 MPa**

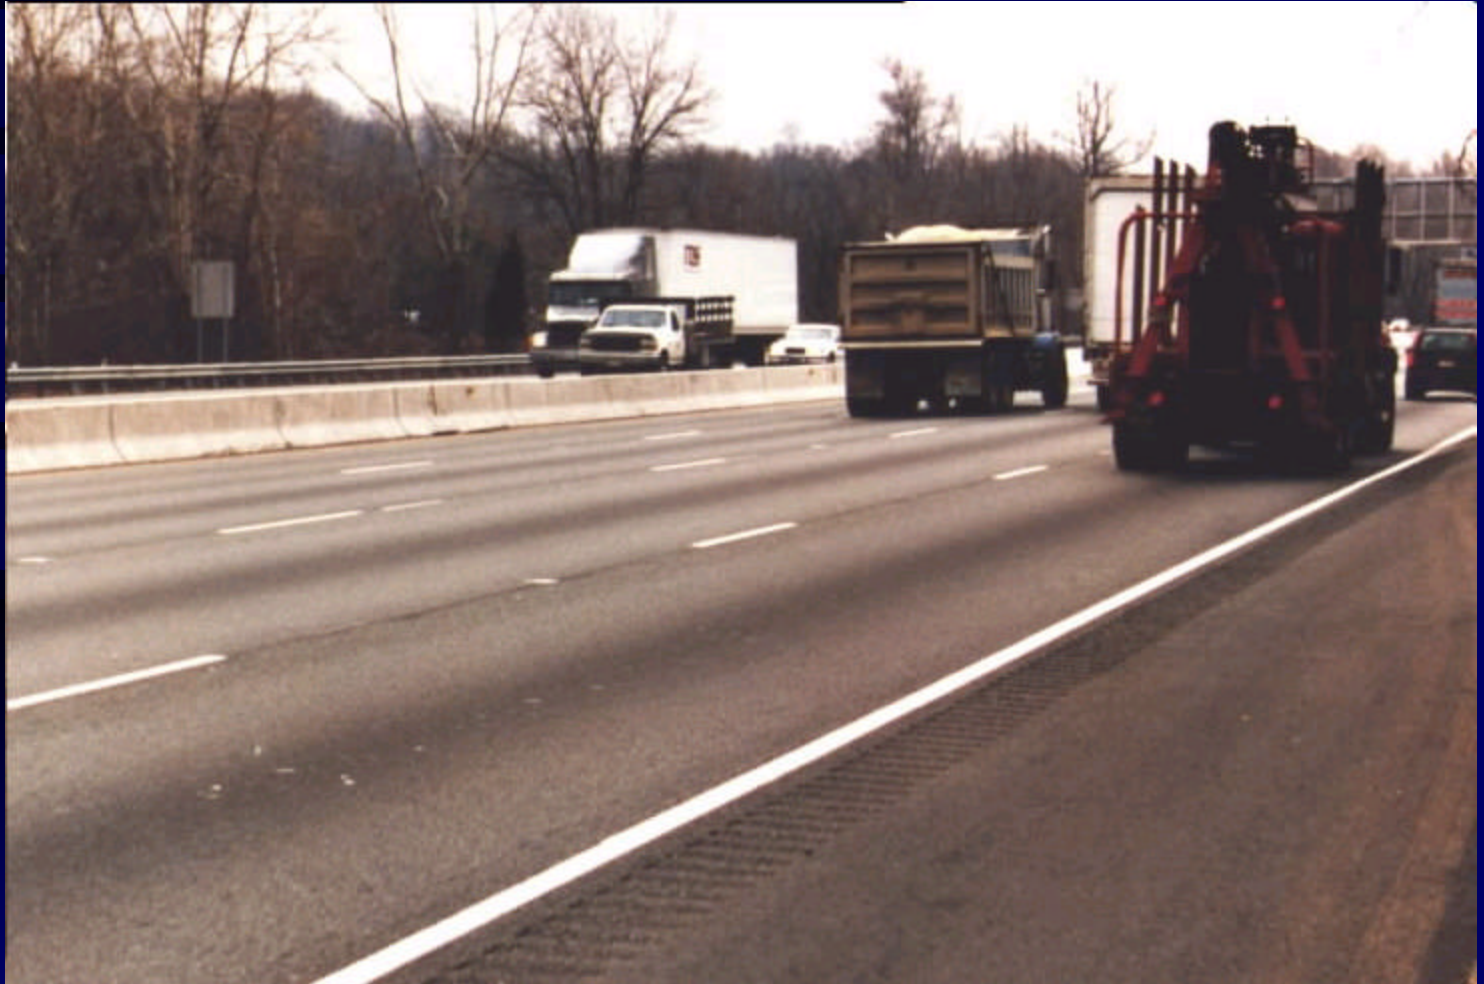
Current Rt. I-287 Condition

- Adequate service life achieved with only a relatively thin overlay
- Existing structural capacity 7,000,000 ESALs
- Rehabilitated structural capacity 69,000,000 ESALs
- Superpave mix not much different than New Jersey's current "HD" mix
- 2001 PMS data indicates zero defects

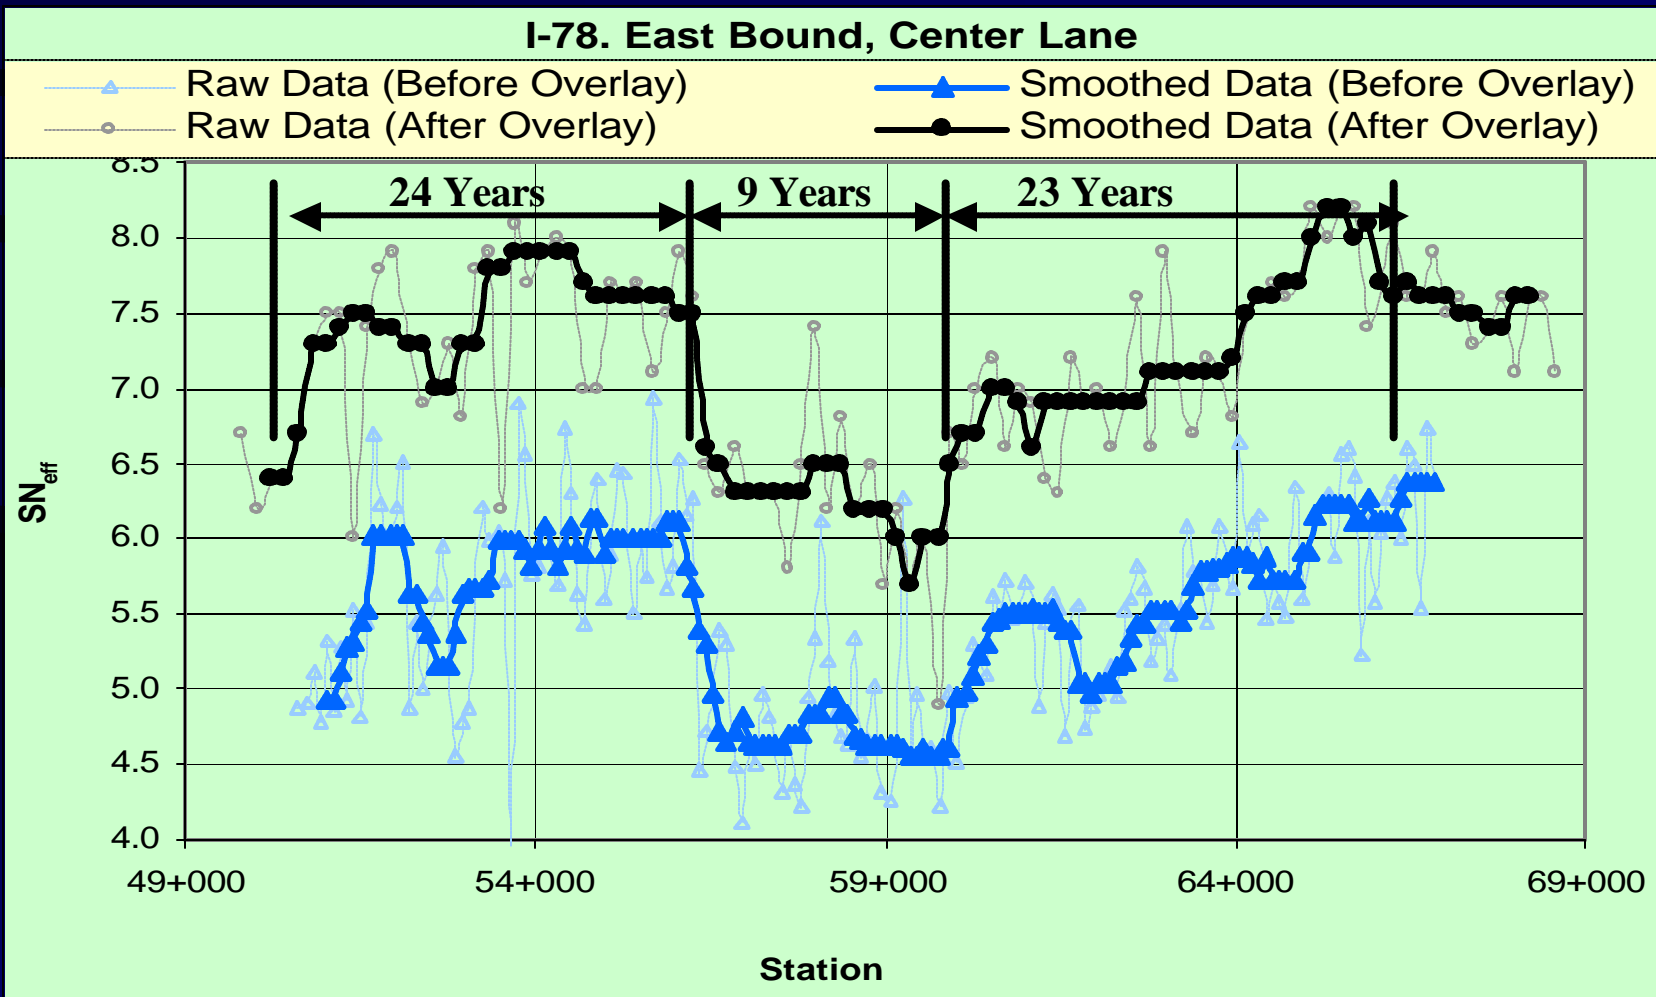
FWD Typical Results Pavement Evaluation Route 78 EB MP 30.5 to MP 42.7

Lane	Before Overlay		After Overlay	
	E_{AC} MPa (ksi)	SN_{eff}	E_{AC} MPa (ksi)	SN_{eff}
Left	5799 (830)	5.6	8400 (1210)	7.1
Center	3900 (570)	5.6	6100 (890)	7.1
Right	6300 (900)	5.4	7900 (1150)	7.0
Auxiliary	6600 (950)	5.5	6700 (970)	7.2
