High Performance HMA

NEAUPG

October 18, 2001

U.S. 40 & Rt. 213 - Elkton, MD

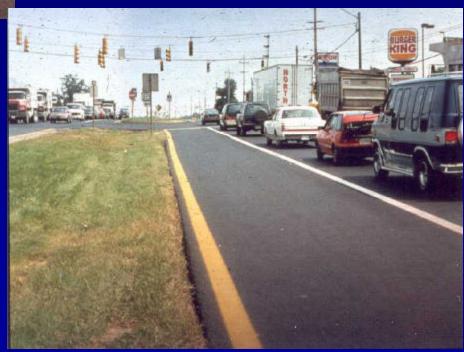
From this

To this

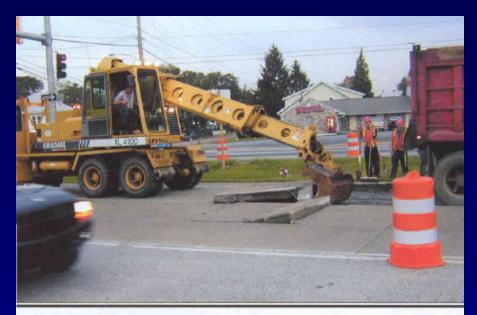
T.C. Simons crews remove 6 1/2" whitetopping at US 40 & Landing Road.

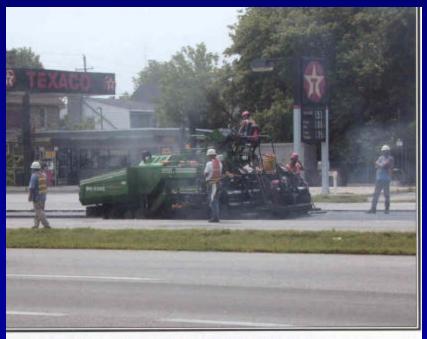
Superpave replaces deteriorated concrete at Landing Road.
